# **FIRE SAFETY STUDIES IN THE RESTORATION OF A HISTORIC WOODEN TOWNHOUSE IN KYOTO - FIRE SAFETY EXPERIMENTS ON JAPANESE TRADITIONAL WOOD-BASED CONSTRUCTIONS**

**Keywords:** Quasi-fireproof test, soil wall, traditional construction method, traditional wood-base material.

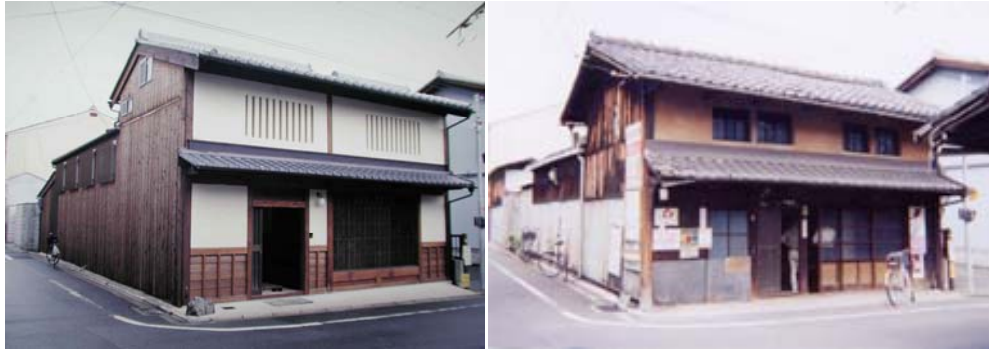
**Photo 1:** The Restored town house in Nishijin district of Kyoto.

Two replicas were produced for two different specifications of soil walls as shown in Figure 1. Mr. Koichi Kinoshita, master of Sukiya-style traditional wooden constructions, produced these specimens. One specification was to reproduce the external wall of the restored town house in Nishijin district (seen in the left, Photo 1). These specimens A and B, are referred to as KN type in this paper. The other specification, test specimens C and D, were prepared essentially according to the soil wall method widely used in Kyoto, and was further strengthened with a 20 mm thick external mortar layer. These will be referred to as the “common type”.

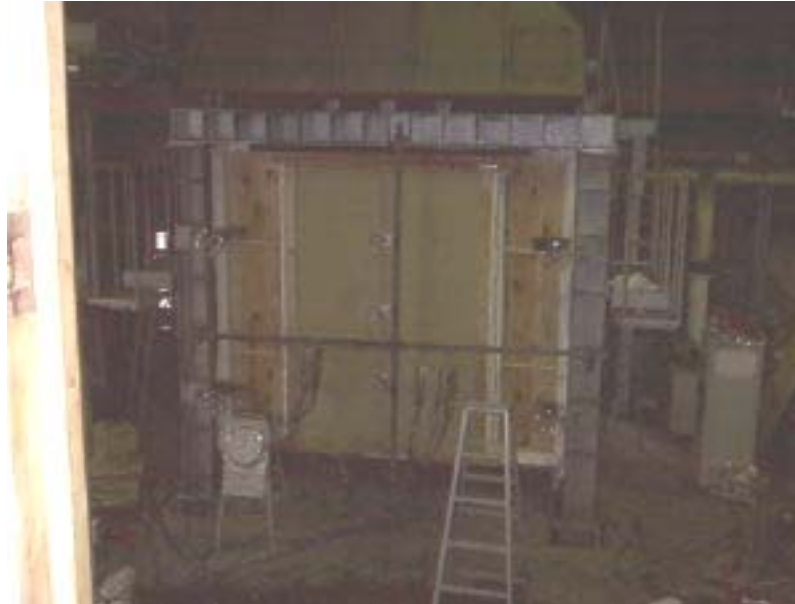
**Photo 2:** The loaded fire resistance test.

The test specimens were installed in the center of the loading frame attached to the heating furnace. Photo 2 depicts the test scene. The heating was made from the “external” side of each specimen.

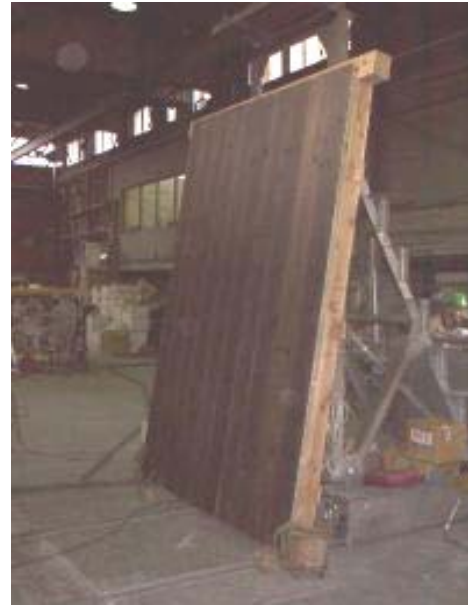
**Photo 3:** KN type specimen (furnace side).

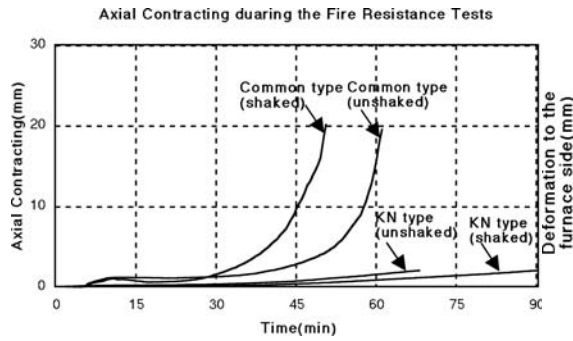
**Figure 5:** Axial ontraction during the Fire Resistance Tests.

Figure 4 is the time history of the temperature at measurement position (III in Figure 3) obtained from all the four tests. Figure 5 and Figure 6 are the axial contractions and deformations of the specimen normal to the wall surface respectively. The observations during and after each test can be summarised as follows:

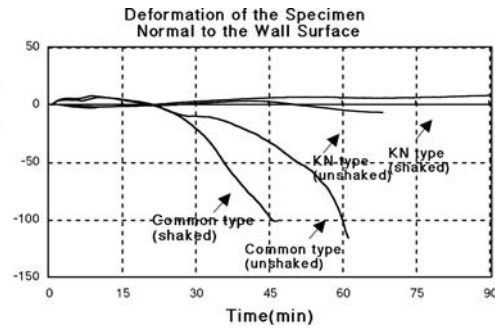
**Figure 6:** Deformation of the Normal to the Wall Surface.
