Ignition Behavior of Firebrands Landed on Roofs with Roof-tile Deficit after an Earthquake

Hideki Yoshioka¹, Yoshihiko Hayashi²,
Yoshifumi Ohmiya³, and Takafumi Noguchi¹

Abstract

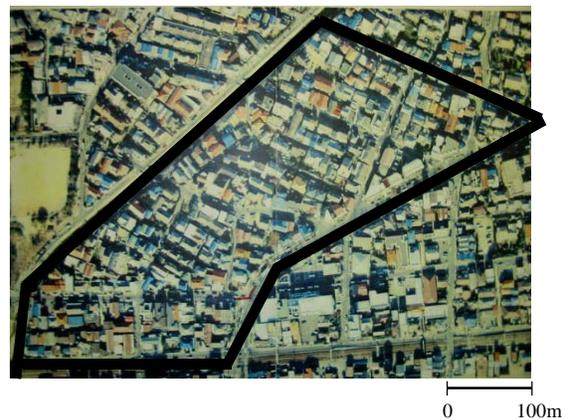
Photo 1. Portion of aerial photography (area 1 is shown as framed).

The relationship between the extents of roof tile deficit and structural damage was studied about the same building in the survey areas. The extent of roof tile deficit was determined visually for each building based on aerial photography (Photo 1) taken from the sky after the earthquake. The extent of structural damage was determined according to structural damage survey results for each house^{Note1)} conducted by the Building Research Institute on site soon after the earthquake [1, 2]. Note that this analysis addresses only wooden houses with tiled roofs. The number of such houses are 302, 191, and 130 in areas 1, 3, and 4, respectively, and 336, 156, and 315 in areas 2, 5, and 6, respectively. These houses constitute a large portion of all buildings in every area.
