F.R. Note No.436.

EXTERNAL WALLS OF BUILDINGS - PART I

THE PROTECTION OF OPENINGS AGAINST SPREAD OF FIRE FROM STOREY TO STOREY

L. A. Ashton and H. L. Malhotra

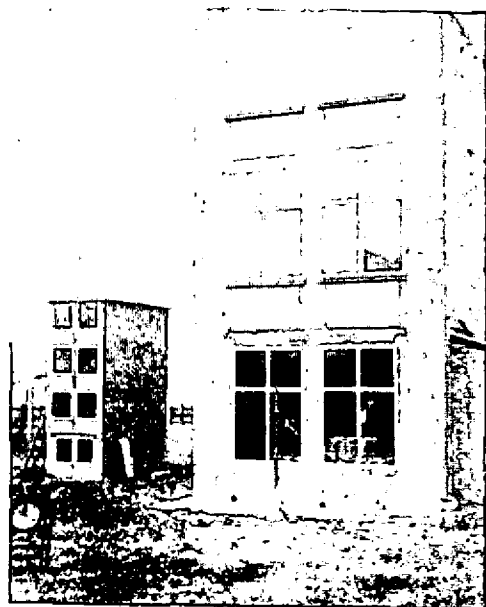
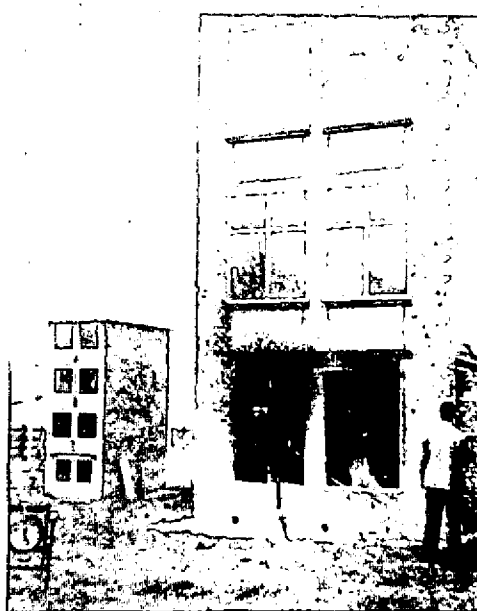
PLATE 1.

a. Start of fire

b. Emission of flames from
ground floor room (12 min.)

c. Fire burning in fire
chamber (20 min.)

d. End of test (25 min.)

TEST N^o. 1. A/C SHEETING AND PLASTERBOARD PANELS

The fire developed very rapidly in this test and by $4\frac{1}{2}$ min. most of the glazing had been broken in the ground floor room and the flames from the windows cracked some panes in the first floor. The wind was rather strong and, blowing across the face of the building, tended to sweep the flames to one side. Just after 5 min. one of the window panes on the first floor fell down and an asbestos/cement facing of an underwindow panel was shattered. Glazing on the first floor continued to break up and after 7 min. the second asbestos/cement facing exploded and the exposed face of plasterboard began to char. The intensity of flaming decreased after $10\frac{1}{2}$ min. and the fire was almost out at 15 min. The first floor window frames were charred, most of the glazing broken and cladding of the wall panels had disintegrated. The fire did not enter the first floor and no damage to the contents of the room was observed. With the exception of a broken window pane on the second floor, no damage occurred to the higher storeys.

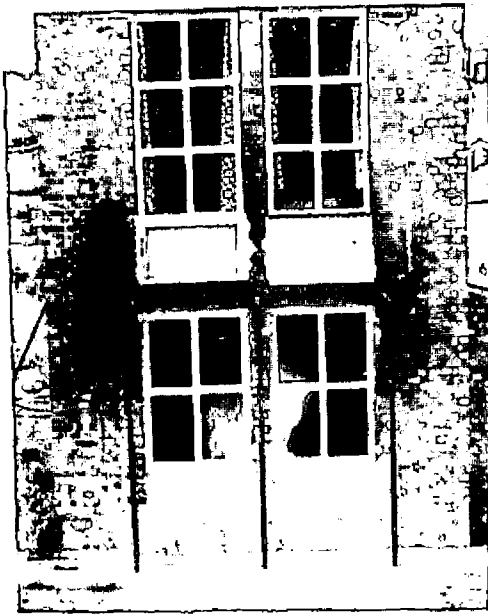
a. Start of fire

TEST N^o. 11. WIRED GLASS AND PLASTIC FACED PANELS
