Experimental Study on Thermal Breakage of Four-Point Fixed Glass Façade

KEYWORDS : Glass façade, thermal breakage, safe distance, fire resistance

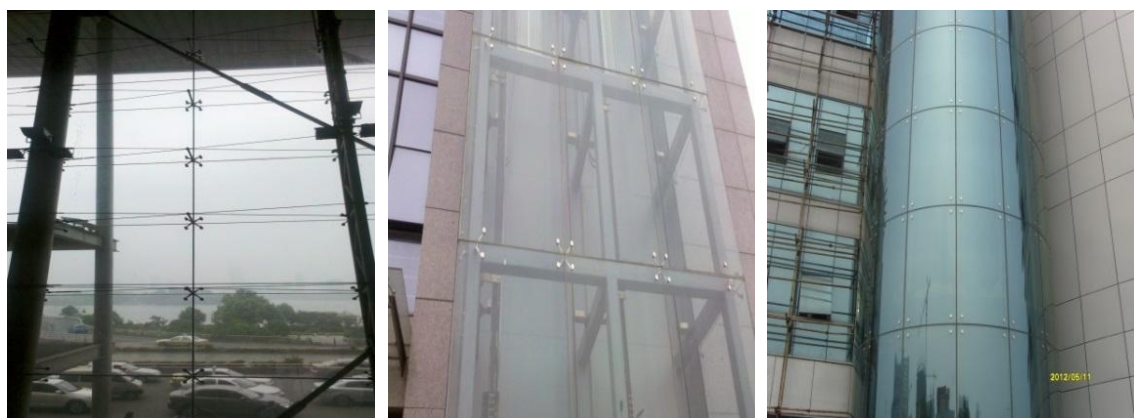
(a) The first-tier city Nanjing

(b) The second-tier city Hefei

(c) The third-tier city Huainan

Fig. 1. The glass curtain wall in three typical cities.

Glass façades are used extensively in modern high-rise buildings due to its transparency, energy saving potential and architectural aesthetics [1]. The authors conducted a site survey in the Yangtze River Delta region of China and found that many building surfaces are constructed with glass curtain walls instead of concrete or steel. This is even more common in newly constructed buildings. Figure 1 shows some widely used four-point supported glass curtain walls in three Chinese cities.

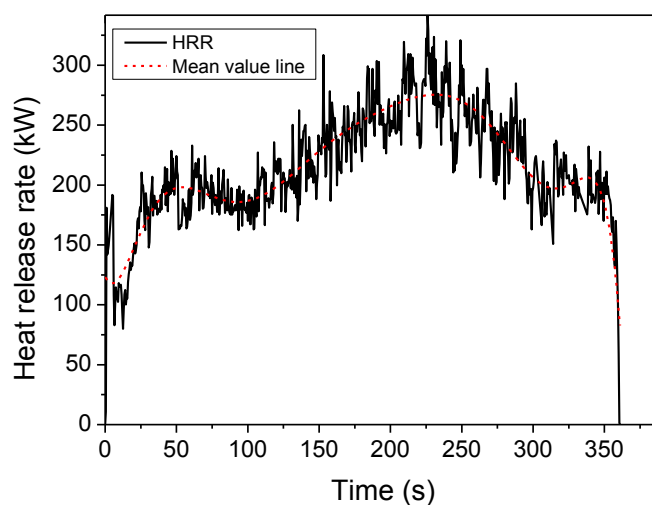
Fig. 5. Typical heat release rate vs time.

where the burning rate of the fuel varied with time. The combustion efficiency factor α was taken as 0.75 following ISO 9705 [21]. The heat of combustion of n-heptane ΔH is 48066 kJ/kg. The heat release rate versus time in Case 1 is shown in Fig. 5. At 361 s, the maximum HRR of 324 kW was observed. The glass broke at 89 s with a HRR of 198 kW. The time to the first crack in other cases are summarized in Table 2. It was found that the tested glass pane broke and fell out before the HRR reached the maximum value while the fire was still in the development stage.

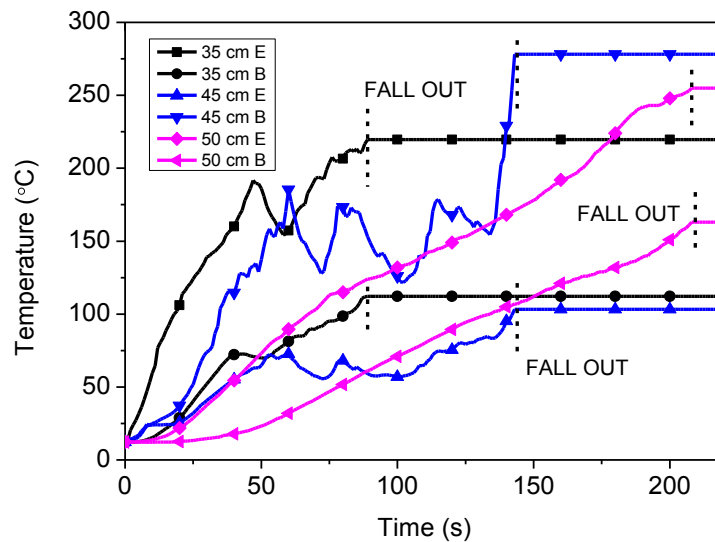
Fig. 10. The glass pane centre temperatures vs time in Cases 1-3.

Temperature variations in Cases 1 and 2 are similar to Case 3 except that the value being smaller. The central temperature on the glass pane is a representative parameter that can intuitively demonstrate the thermal state. The centre temperatures on the exposed and back sides in Cases 1-3 are shown in Fig. 10. It can be seen that the exposed side temperatures all exceeded 200 °C and back side temperature exceeded 100 °C after glass fallout. Being closer to the fire, the temperature in Case 1 increased more quickly than in the other cases. But the thermocouples were also more easily affected by the fire. As a result, considerable temperature fluctuations were recorded in Cases 1 and 2. For all cases, the variations of temperatures on the exposed and back sides follow similar patterns. The temperature and other parameters at breaking time are summarized in Table 2. The central temperatures on the exposed side at breaking time were all within the range of 200-300 °C. Back side temperatures were within the range of 100-200 °C. These findings are consistent with our previous studies [23] in which different fixing methods were investigated. Considering the randomness of glass breaking [4, 24], the measured temperatures here are relatively steady, indicating that the length of time in which the glass is being continuous heated has limited influence on glass breakage. The temperature distribution has much more influence on glass breakage than the heating period for the point-fixed glass pane subjected to a fire.

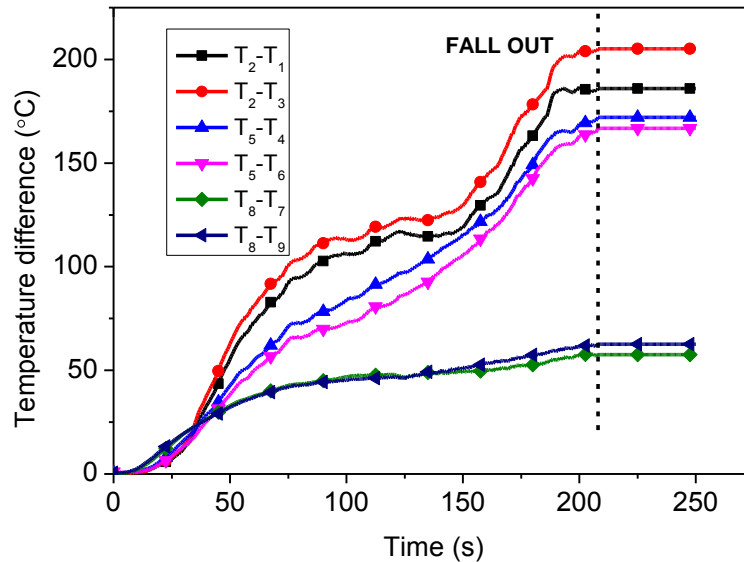
Fig. 11. Temperature differences at different monitoring points vs time in Case 3.

These results suggest that ΔT is a significant parameter for determining the breakage of glass, in the Eq. (2) [10]:

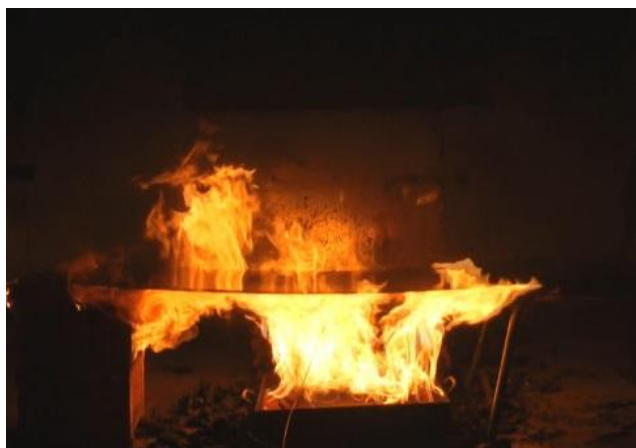
Fig. 12. Image showing the 6 mm toughened glass subjected to fire.

30 cm above the ground. It was fixed onto two supporting metal cube to ensure that the fire could impinge directly on it. The same pool fire lasting more than 5 minutes was used to impose thermal loading. It can be seen from Fig. 11 that the glass was softened and bent in the middle but no crack was observed, demonstrating its relatively good fire resistance performance.
