Effects of Cathedral and Beamed Ceiling Construction on Residential Sprinkler Performance

ROBERT G. BILL, JR., HSIANG-CHENG KUNG, WILLIAM R. BROWN, and EDWARD E. HILL, JR.

Factory Mutual Research Corporation 1151 Boston-Providence Turnpike Norwood, Massachusetts 02062, USA

FIRE SAFETY SCIENCE—PROCEEDINGS OF THE SECOND INTERNATIONAL SYMPOSIUM, pp. 643-653

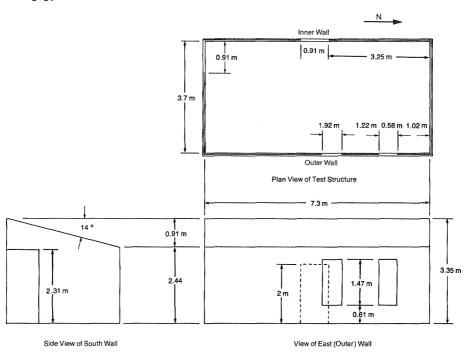
DRAWING NOT TO SCALE

Figure 1. Three views of test room.

All fire tests in this program were conducted in a 3.7 m x 7.3 m test room constructed within a 18.3 x 18.3 x 4.7 m test facility at Factory Mutual Research in Norwood, MA. In all tests, the fire products were vented to the larger volume surrounding the test room, hence the ventilation in a house is not realistically simulated. Figure 1 shows the dimensions of the test room. The ceiling of the test room was constructed so that one side (the west or inner wall) could be raised or lowered hydraulically. In this study the ceiling was either horizontal or pitched to a 14° slope; i.e. the elevation of the ceiling at the west wall was 2.44 m or 3.35 m.
