# Large Scale Fire Tests of a 4-Story Type Car Park

## Part 2: Analysis of the thermal stresses and deflections

T.HIRASHIMA, Y.WANG and H.UESUGI

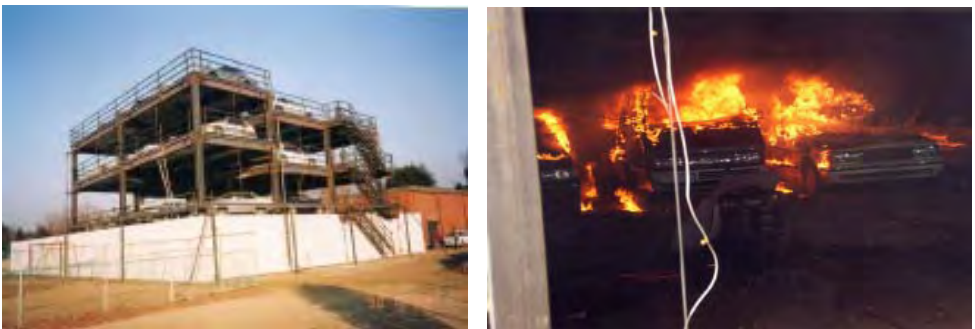
**FIGURE 1.** The external view of the experimental structure and the view of the spreading car fire during the experiment

Fig.1 shows the external view of the experimental structure and the view of the spreading car fire during the experiment. Fig.2 shows the plan of the ground floor. This experiment is performed by starting a fire at the deepest part of the thermally insulated corner on the ground floor. The structural members are covered with no fire protection. The maximum allowed floor area for prefabricated parking structure is  $4000\text{m}^2$  by a floor in Japanese specification. If the area is square, the dimensions are  $63\text{m} \times 63\text{m}$ . A fire started in the center of the floor is thought as the most violent type possible. In order to achieve the fire conditions described above, a thermally insulated structure is used to form a combustion space. This space is surrounded by the ceiling (floor of the second story) and walls on ⑤-line and E-line. Combustion progress is considered more severely because of heat radiated from the floor and walls to cars in the insulated space. Therefore, the corner side fire exhibits faster combustion and spreads wider than the open side fire. The purpose of the experiment is to understand the behavior of car combustion and structural frames under this extreme condition.

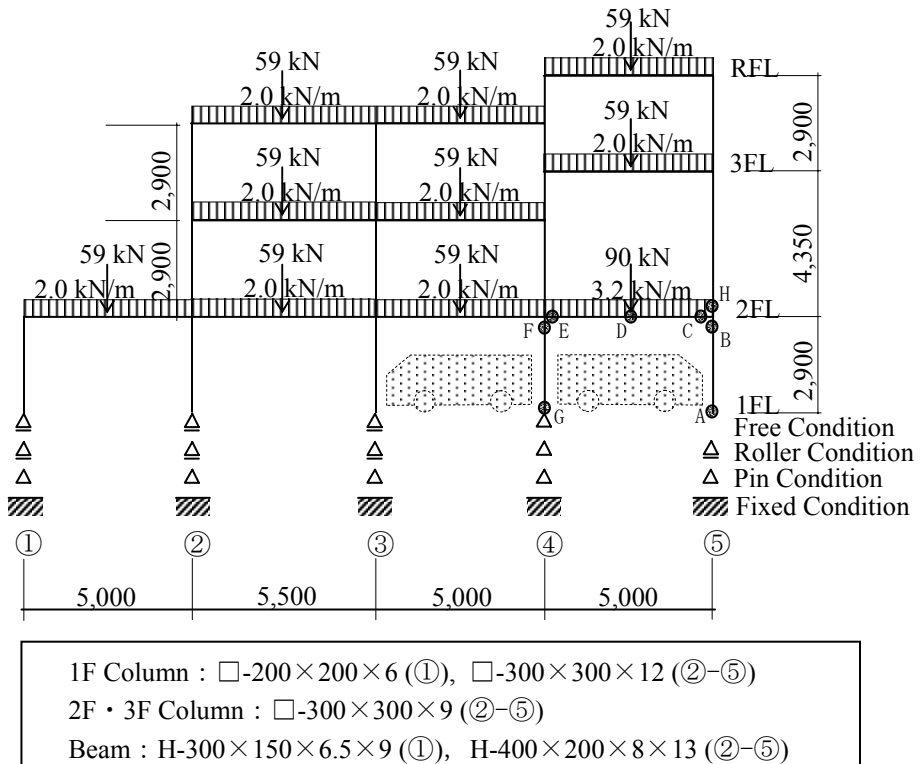
FIGURE 3. Side elevation of analytical frame (E-frame)

Fig.3 shows side elevation of analytical frame (E-frame). As shown in Fig.2, E-frame is subjected to severe fire because columns and beams at the ground floor are located between burning cars and auto-craved aerated concrete wall. In this experiment, the sets of two wide flange shapes with small section are put on the each line of ①-⑤ instead of footings which cannot be located in the ground. And the partial inner columns are connected to these wide flange shapes by high-tension bolts. Therefore, this analysis is conducted under the four kinds of support conditions of the column base as shown in Fig.3. At first, it is assumed that the point of ④line's column base, which move little in horizontal direction in this experiment, is fixed for horizontal movement. In case1, ⑤ line's column base is not supported at all and other ones are in roller bearing except ④ line's column base, named "Free Condition" in this paper. In case2, all column bases are in roller bearing except ④line's column base, named "Roller Condition". In case3, all column bases are in pin bearing, named "Pin Condition". In case4, all column bases are fixed on the ground, named "Fixed Condition". Free Condition and Roller Condition simulate roughly this experiment. Pin Condition and Fixed Condition simulate a general car park building structure.

Fig.6 shows thermal deformation of the frame. In this picture, frame displacement lines are drawn by 5 minutes during a heating phase. Fig.7 shows thermal deflection of outer column and beam exposed to fire. In Fig.7, the experimental results are compared with calculated ones. The symbols A, C, D and H denote the points as shown in Fig.3.

The curvatures of fire exposed column and beam are shown in Fig.8. The symbols from A to G denote the points as shown in Fig.3. As shown in Fig.8 (a) and (b), in the case of Free Condition and Roller Condition, the value of beam's curvature at the inside end reaches 2.5 times of the room temperature's yielding curvature at 45 minutes after ignition and remains near to 2 times at 80 minutes after ignition. As shown in Fig.8 (d), in the case of Fixed Condition, the value of the outer column's curvature reaches 5.5 times of the room temperature's yielding curvature at 45 minutes after ignition and remains 4.5 times at 80 minutes after ignition. When the column bases of a frame are restrained for the horizontal displacement by footings, large curvatures are developed at the top of outer columns due to the thermal elongation of the beam exposed to fire, and they remain after a fire.

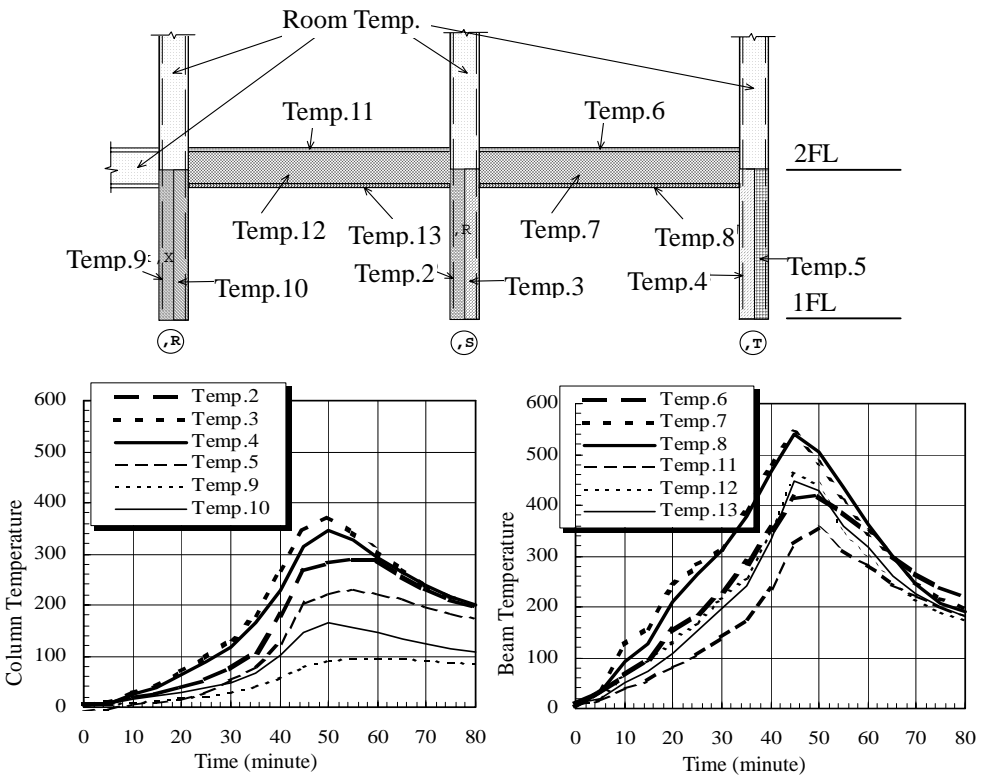
**FIGURE 4.** Structural steel temperatures

Fig.4 shows the distribution of structural steel temperatures in this analysis. Temperatures of members for axial direction are given as uniform distribution and for sectional direction are given as variable distributions on the bases of experimental results. In this test, fire fighting is started at 44 minutes after ignition.

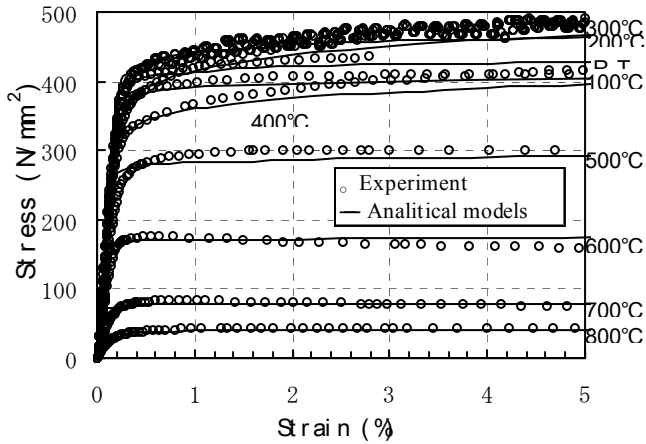
**FIGURE 5.** Stress-strain curves of the steel column

Fig.5 shows stress-strain curves of the steel column at elevated temperature. The stress-strain curves of the steel beam are approximately as same as column's one. The analytical model of SS-curve is based on the tension tests of these materials.

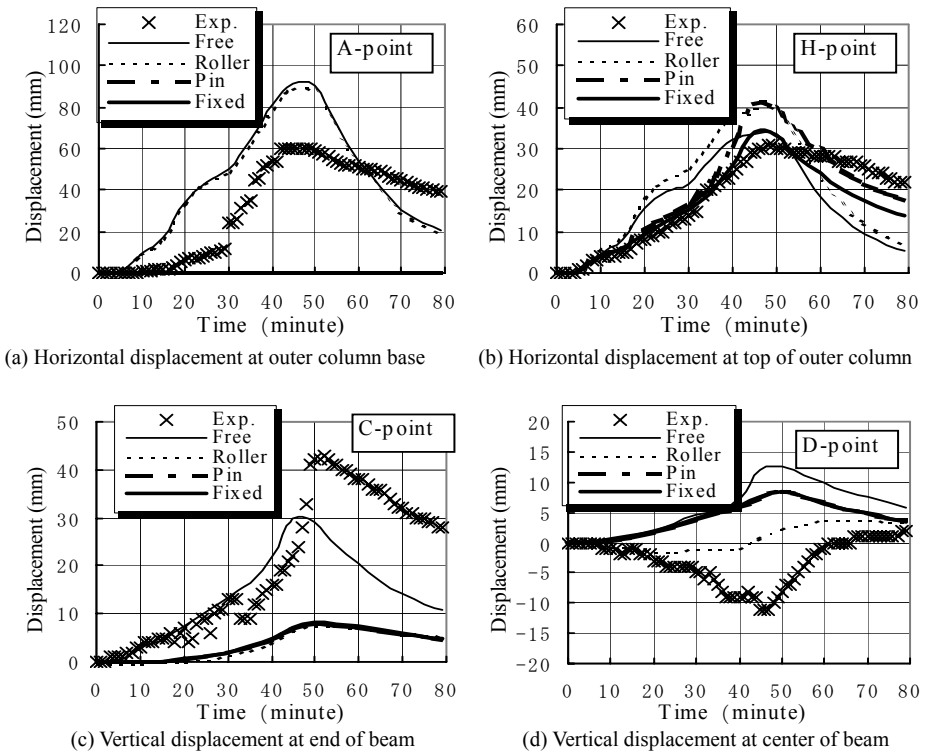
FIGURE 7. Thermal deflection of outer column and beam exposed to fire

At first, the frame doesn't collapse as same as the experiment. In the case of Free Condition, ⑤line's column is lifted up according to fire development time as shown in Fig.6 (a). About the vertical displacement at the end of beam as shown in Fig.7 (c), the calculated values approximately agree with the experimental values during a heating phase. As shown in Fig.6 (a) and (b), in the case of Free Condition and Roller Condition, outer column is pushed out due to the thermal elongation of the beam exposed to fire. About the horizontal displacement at the outer column base as shown in Fig.7 (a), the calculated values are somewhat larger than the experimental values. As shown in Fig.6 (c) and (d), in the case of Pin Condition and Fixed Condition, large bending deflections are developed at the top of outer column due to the thermal elongation of the beam and the restraint of column base displacement for horizontal direction. About the horizontal displacement at the top of column as shown in Fig.7 (b), the calculated values agree with the experimental values. As shown in Fig.7 (d), vertical displacement at center of beam exposed to fire is yielded downward in the experiment, but this displacement is yielded upward in the analysis. It is considered that the deflection of beam is influenced largely by the three-dimensional factors due to the behavior of the fire exposed slab and beam meeting at right angles. It is difficult to describe the experimental deflection of the beam exposed to fire by two-dimensional analysis.

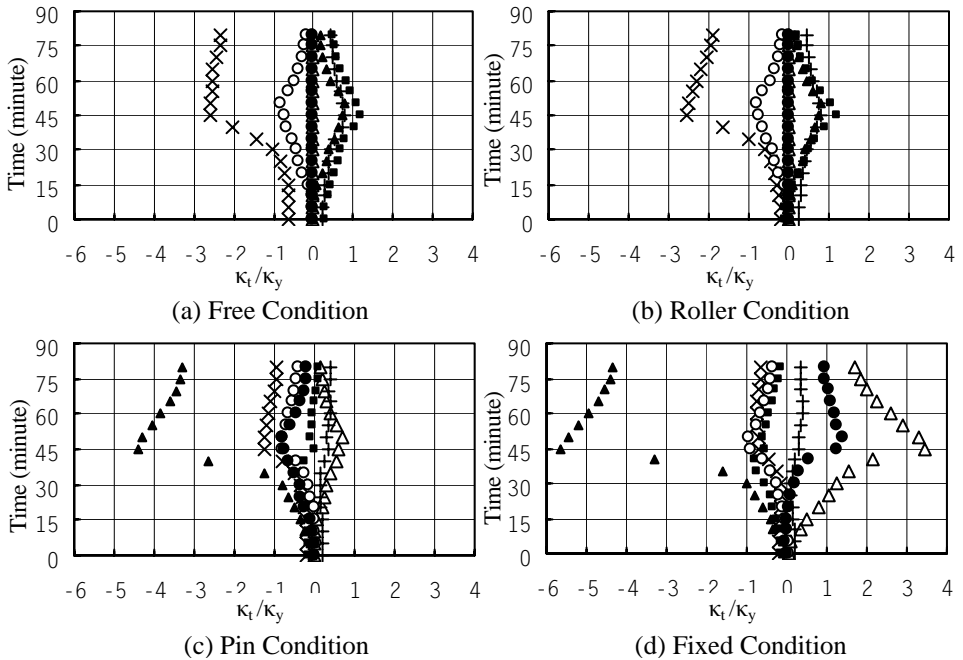
$\kappa_t$  : Curvature at Elevated Temperature ,  $\kappa_y$  : Yielding Curvature at Room Temperature  
 :outer column base (A), ▲:top of outer column (B), ■:outside end of beam (C), +:center of beam (D),  
 ×:inside end of beam (E), ○:top of inner column (F), ●:inner column base (G)

**FIGURE 8.** Curvatures of fire exposed column and beam
