CONDUCTING A FULL-SCALE EXPERIMENT ON A RAIL PASSENGER CAR

N. White and V.P. Dowling
CSIRO Fire Science and Technology Laboratory
PO Box 56 Highett, Victoria 3190, Australia

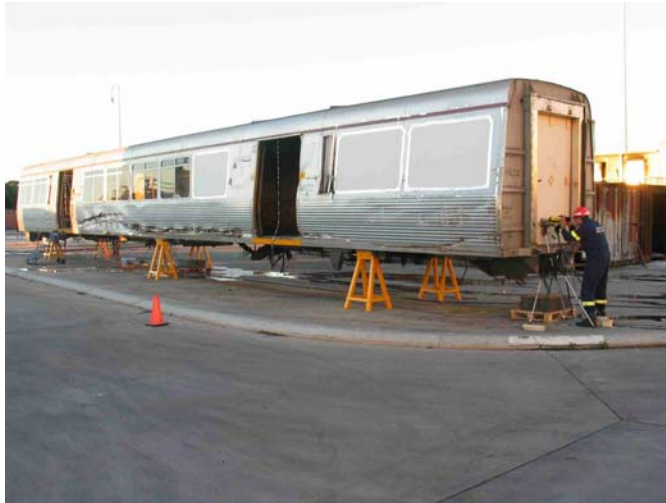
Figure 1. Carriage shell used for fire experiments

The carriage became available after an accident that did not involve fire. The carriage consisted of a stainless steel shell. It was fitted with plywood flooring, insulated wiring and glass fibre insulation behind aluminium and plywood surfaces in the floor, walls and ceiling. All other materials and fittings had been stripped, including air conditioners and doors. The carriage was approximately 23 m long having two doorways on either side and a doorway at either end. The carriage had some penetrations through the floor and walls that were patched for the experiments.

The carriage and materials tested were selected from scrap stock. The combination of materials tested was not representative of any particular vehicle in use. Rather it was intended as representative of a typical Australian suburban rail passenger vehicle (Figure 1).

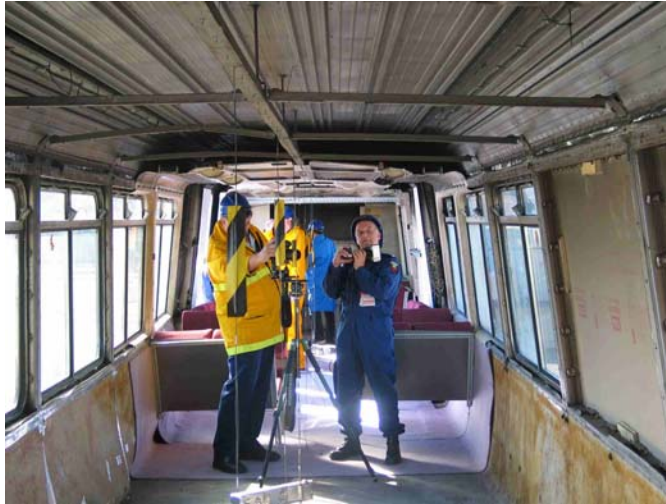
Figure 2. Interior of carriage prior to full-scale fire experiment

Both end doorways and the two doorways on one side were sealed with plasterboard. Both doorways on one side were left open, representing a scenario where the train had stopped at a platform and the passengers disembarked.

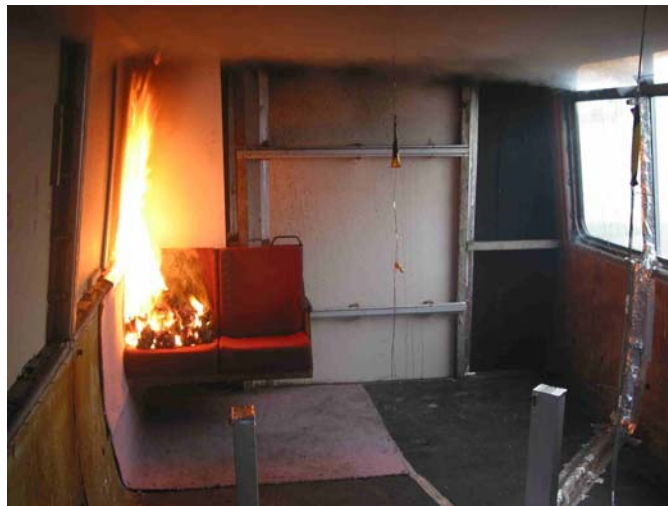
Figure 3. Typical ignition experiment

All experiments were initiated using a gas torch. In those cases where the fire spread to the extremity of the corner lining, it was observed that the fire had reached a sufficient size to continue growth to a fully developed carriage fire if more materials had been present. Once fires had grown to this size they were suppressed to avoid damage to the carriage structure (Figure 3).

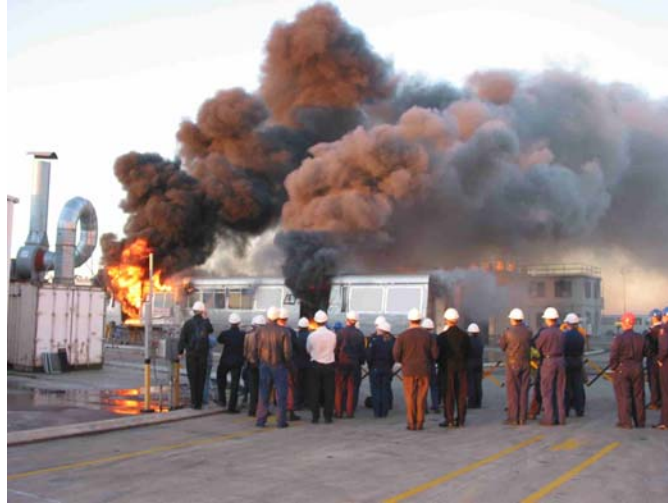
Figure 4. Smoke production from fully developed fire

The ignition source for the fully developed fire was 1 kg of crumpled newspaper piled on the floor in a corner behind the end seat shell. This was ignited using a gas flame. The fire was left to grow until most of the available fuel had been consumed (Figures 4 and 5).

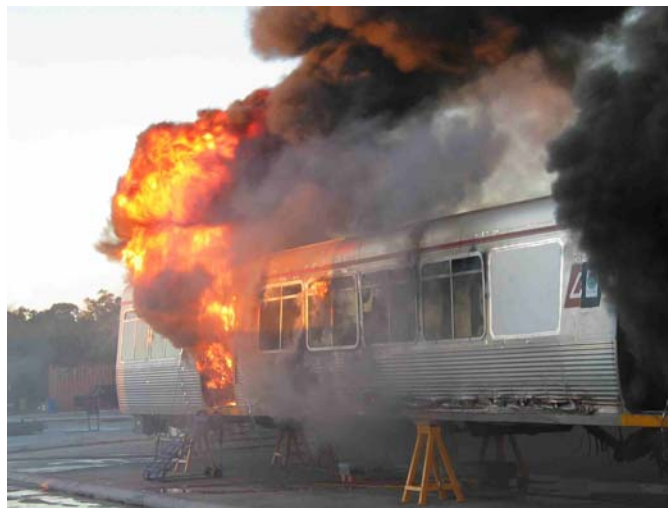
Figure 5. Fire plume through doorway from fully developed fire
